Evaluation of the CRREL Permafrost Tunnel

Kevin Bjella, Thomas Tantillo, Jason Weale, and James Lever

August 2008

Abstract: The Permafrost Tunnel was excavated in frozen silt and consists of a 110-m-long horizontal adit and a 45-m-long winze that extends down to the underlying gravel. Some change has occurred since the excavation was conducted in the mid-1960s, so a team was assembled in the spring of 2006 to assess these changes. Frozen silt deformation was noted in the rear of the adit, and a roof fall of the gravel layer was noted in the room at the bottom of the winze. Both of these were found to be attributable to thermal forcing events and the raising of the overall facility temperature to near-freezing temperatures. Sublimation was also noted throughout the tunnel, but this does not pose a problem for the structural integrity of the facility. The team recommends that the facility temperature be lowered to approximately -5°C , which will decrease creep rates and the weakening of lithologic bonds between soil units. Overall, the facility is safe for continued use by researchers and others.

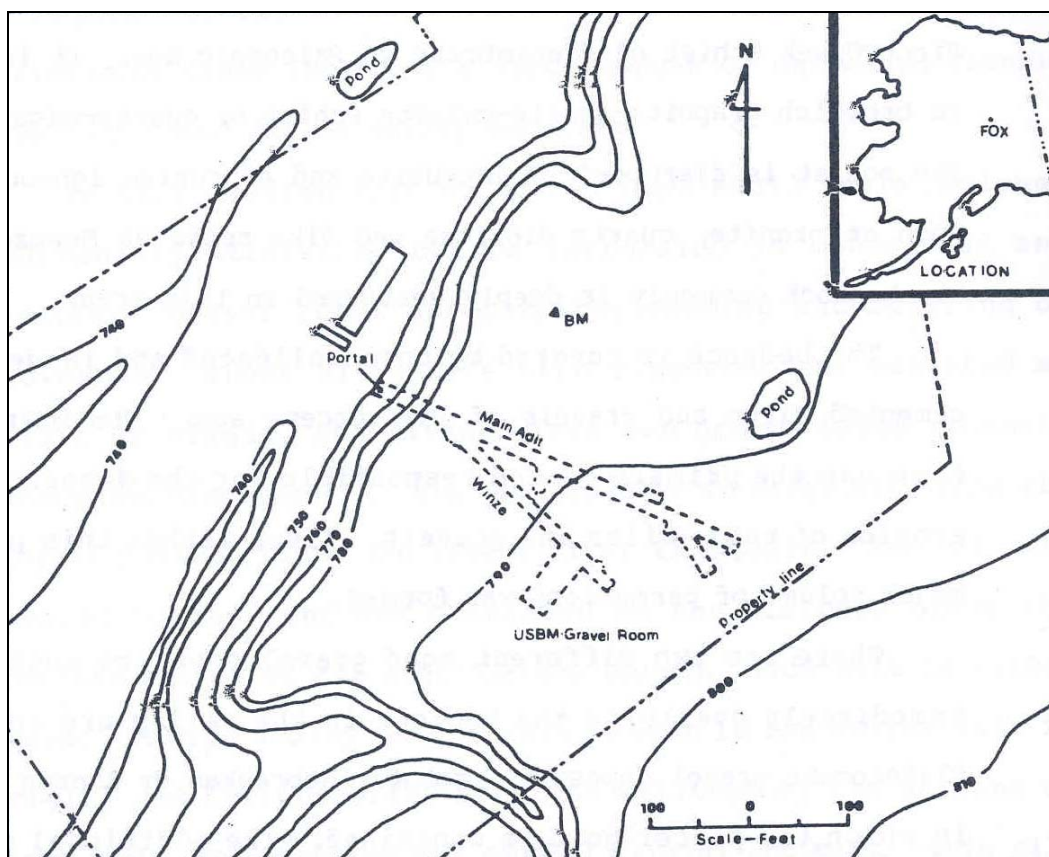
The tunnel is located 16 km north of Fairbanks in Fox, Alaska. It was driven into a nearly vertical silt escarpment that lies at the margin of Goldstream Creek Valley. The valley was historically mined for placer gold, and the escarpment was created by this activity. The geology at the tunnel consists of silt deposits that are Wisconsin to recent in age and eolian (wind blown) in nature and are derived from the glaciers of the Alaska Range. The silts overlie gravels of Nebraskan age that are derived from the surrounding hills of the Yukon–Tanana Upland terrain, and they in turn overlie Pre-Cambrian metamorphic schist bedrock (Sellman 1967). The natural surface over the axis of the tunnel rises gently from the top of the 10-m escarpment and preferentially drains toward Goldstream Creek to the west and Glenn Creek to the north (Fig. 1).

Figure 1. Location of the CRREL Permafrost Tunnel and surface topography.* (From Pettibone and Waddell 1969.)

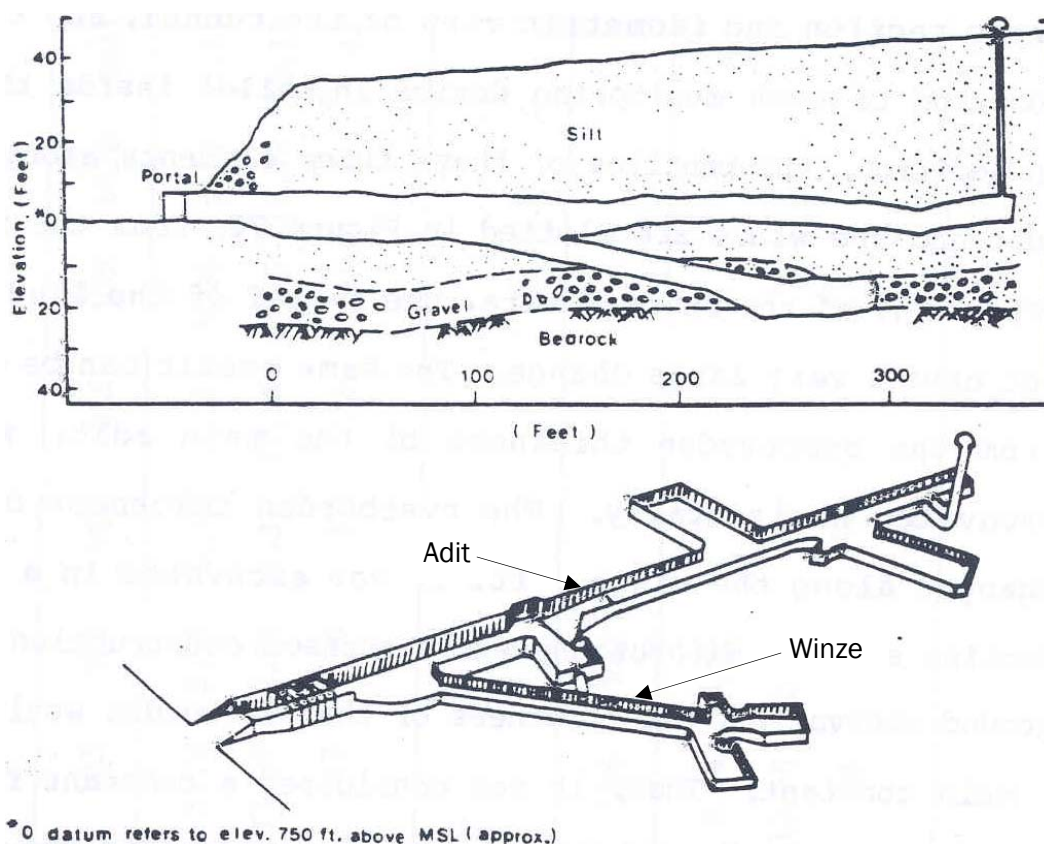
This tunnel is composed of two portions: the adit (a nearly horizontal passage from the surface into a mine), which was driven by the US Army Corps of Engineers using continuous mining methods in the winters of 1963–64, 1964–65, and 1965–66 (Sellman 1967), and the winze (an inclined adit), which was driven by the US Bureau of Mines (USBM) from 1968 to 1969 using drill and blast, thermal relaxation, and hydraulic relaxation methods (Chester and Frank 1969). The adit extends into the scarp 110 m and is predominantly located in the silt unit (Fig. 2). The winze begins approximately 30 m into the adit and drops obliquely at an incline of 14% for 45 m, passing into the gravel unit and ultimately into the weathered bedrock, where a Gravel Room was excavated (Pettibone 1973). At the time of excavation, portions of the Gravel Room roof consisted of a gravel layer up to 2 m thick below the overlying silt unit (Garbeil 1983). After the winze levels out adjacent to the Gravel Room, it continues for another 10 m as a drift into what is known as the CRREL Room. The silt overburden at the thickest point is approximately 14 m over the adit and 18 m over the Gravel Room.

Figure 2. Cross section of the Permafrost Tunnel showing the lithology and the locations of the adit and winze. (From Wu 1985.)

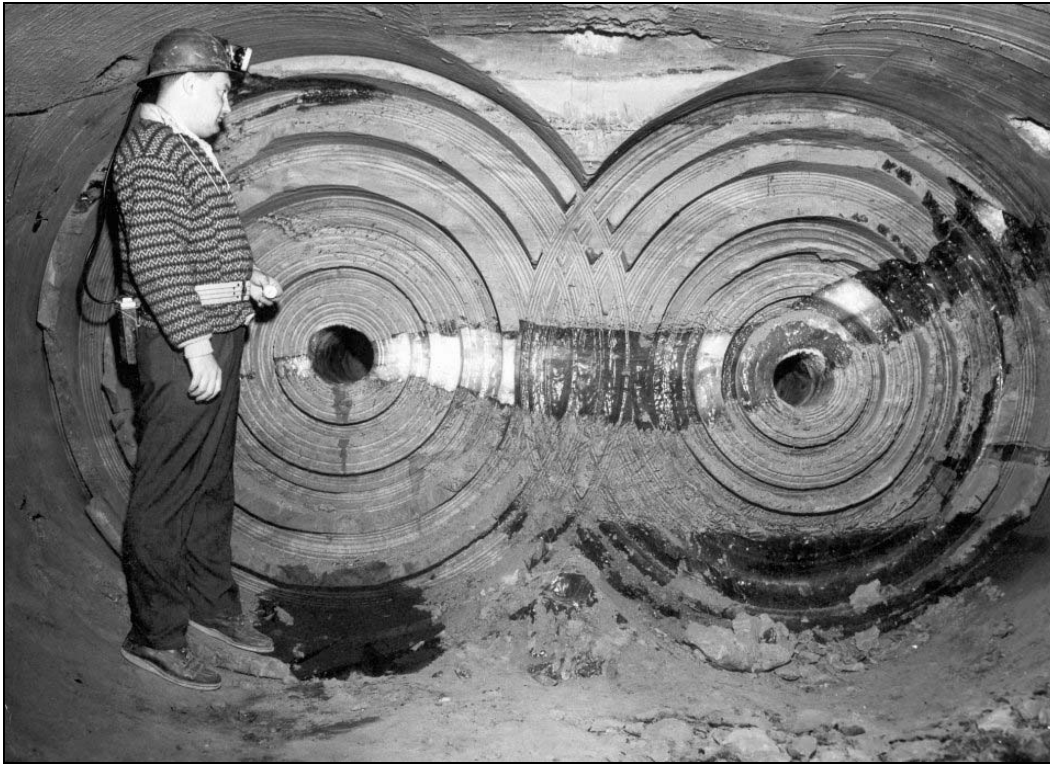
Figure 3. Ice lens during excavation. These features are abundant in the fine-grained soils of the Fairbanks region and are visible in the tunnel. This is one pass of the Alkirk mining machine that excavated the adit.

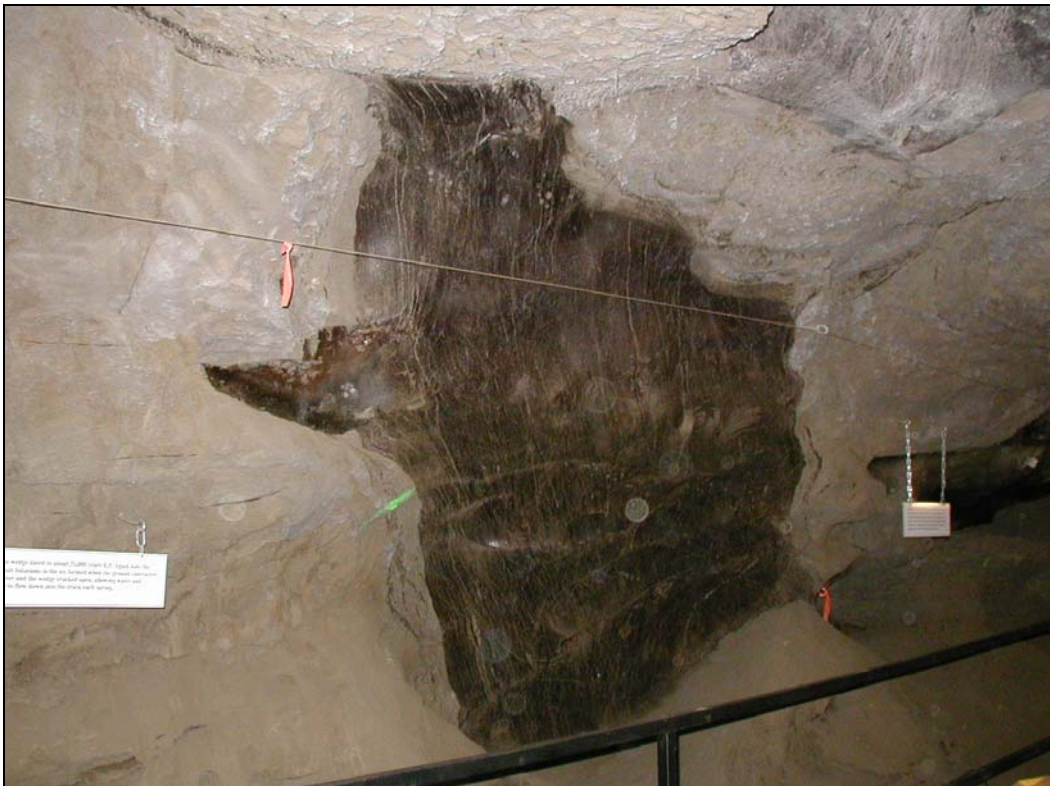
Figure 4. Ice wedge in the adit wall.

of the ice wedge features must have been epigenetic (frozen after emplacement). The ice wedges are probably segments of larger ice-wedge polygon complexes. Sellman (1967) suggested that two major silt units with separate ice wedge development exist in the adit. The major features are illustrated in Figure 5; note the gravel in the rear of the adit.

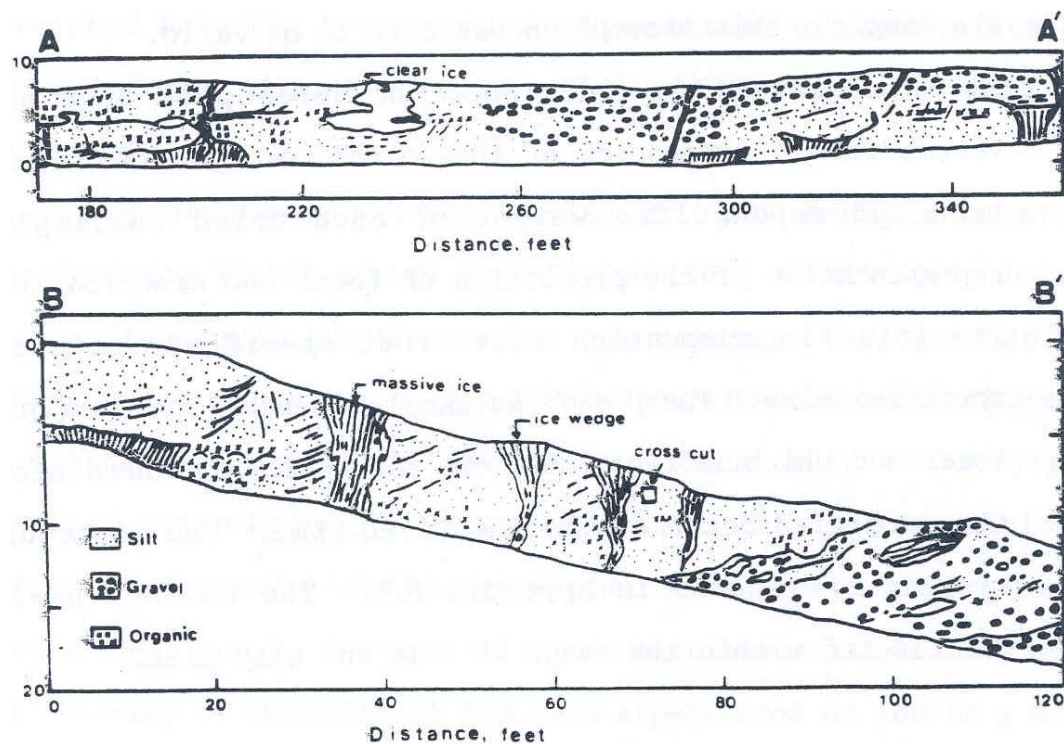
Figure 5. Periglacial features in the Permafrost Tunnel. The rear portion of the adit is the upper diagram, and the winze is the lower diagram. (From Sellman 1967.)

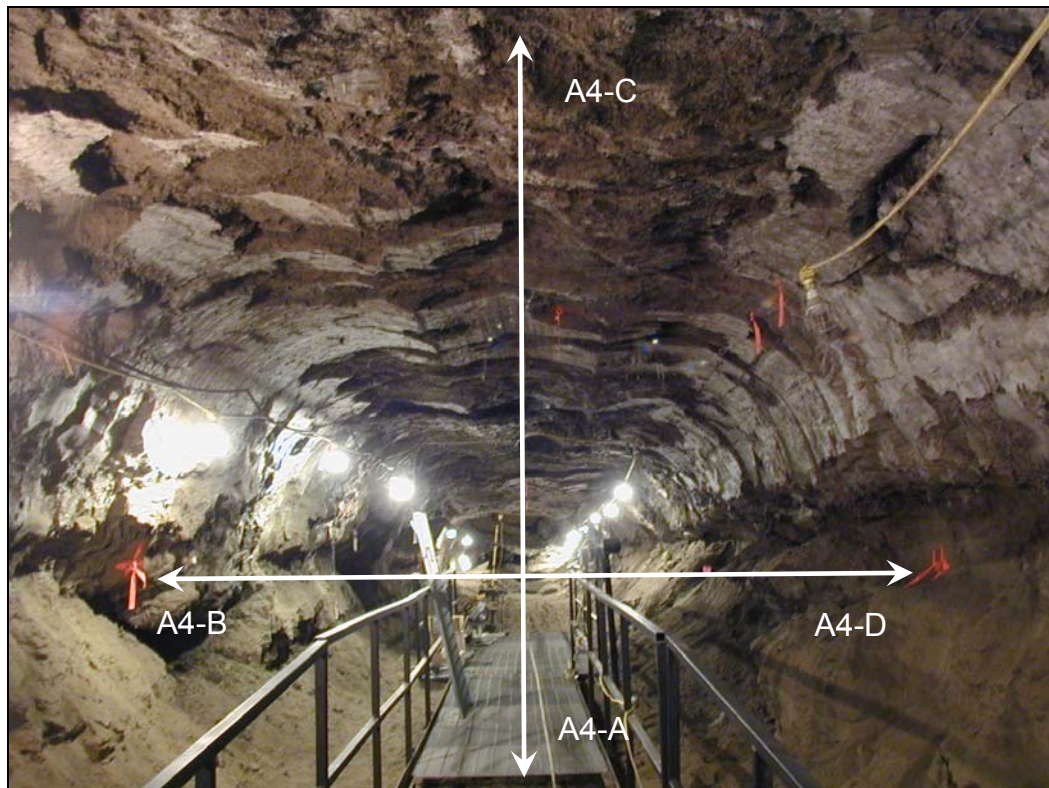
Figure 7. Typical creep reference location numbering scheme, looking up-station toward the face. Alkirk mining machine contours are still visible in the roof of the adit.

The reference locations were designed to be measured with a metal tape extensometer, which measures the relative distance to the nearest 0.001 mm. Tape readings are eliminated in the calculation of changes, so the actual length of the tape is not relevant. Since absolute measurements were not required, it was not necessary to consider the tape catenary or the stickout of reference points. A permanent extensometer reference location was established at the portal bulkhead to verify continued accuracy of the tape extensometer. On either side wall near the bulkhead are 0.95-cm lag bolts located in vertical 10- × 10-cm timber posts. The results of the measurements are located in Appendix D, along with instructions for using the tape extensometer.

Because of the lack of closure measurements, and to determine if any portion of the tunnel facility is accelerating in deformation, we recommend routine creep reference monitoring at least bi-annually. This will require the purchase of a metal tape extensometer; the measurements can be performed by one person in approximately two hours. An underground, warm, frozen fine-grained soil tunnel such as this requires this monitoring, as it will be easy to detect if a portion is beginning to yield to stresses. We installed nine stations to be monitored in the vertical and horizontal orientation, and we also established an extensometer reference location at the bulkhead.

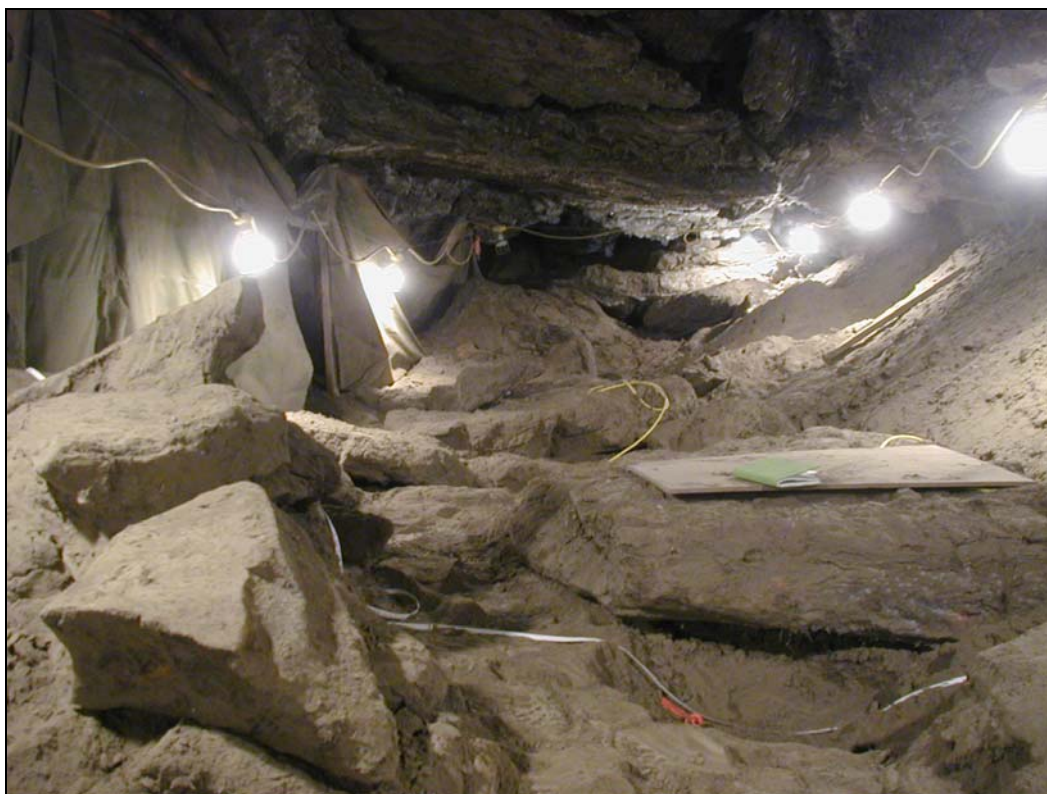
There is no evidence of deformation until approximately 75+00, where the roof is perceptibly and progressively sagging; the adit is almost completely blocked by low-hanging and fallen soil layers at 94+00 (Fig. 8). At this location, overhead layers of soil have delaminated from the bedded sediments above and have crept down toward the floor and eventually detached from the roof. This is a slow, non-catastrophic process. This portion of the adit has evidence of paleo-alluvial deposition and erosion (Sellman 1967), and these laminations contain interbedded layers of gravelly sandy silt, millimeters to centimeters in thickness. These laminations are the preferential locations of the detachment. This slow deformation of the layer apparently can then give way to an abrupt release of portions up to 4 m² when the tensile strength of the soil is exceeded on either end of the catenary. From 94+00 it was possible to negotiate a path for another 5 m through the blocked area and view an additional 10 m of low-hanging and dropped soil layers.

Figure 8. Rear of the adit at approximately 85+00. Bedded layers are delaminating from the roof, and previous fallen layers are lying on the floor. The tarp to Sayles's Room is visible at the left.

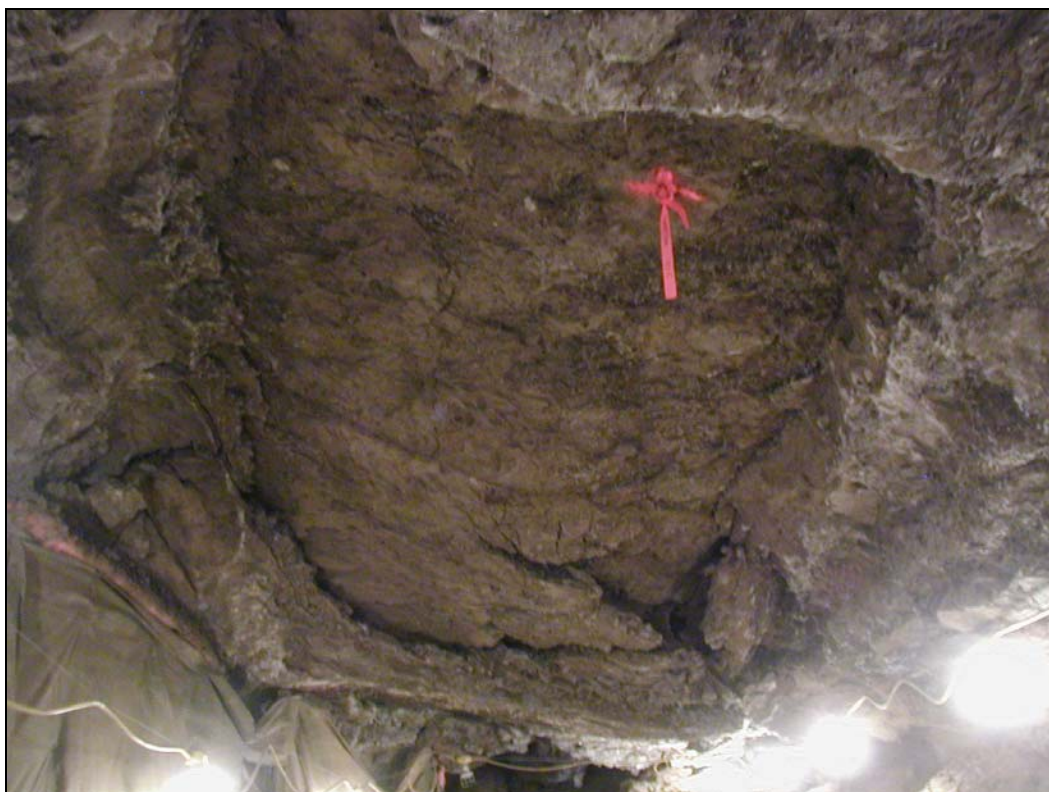
Figure 9. Roof over the area shown in Figure 8, where a layer has delaminated, sagged, crept, and fallen to the floor. The tarp is visible on the left.

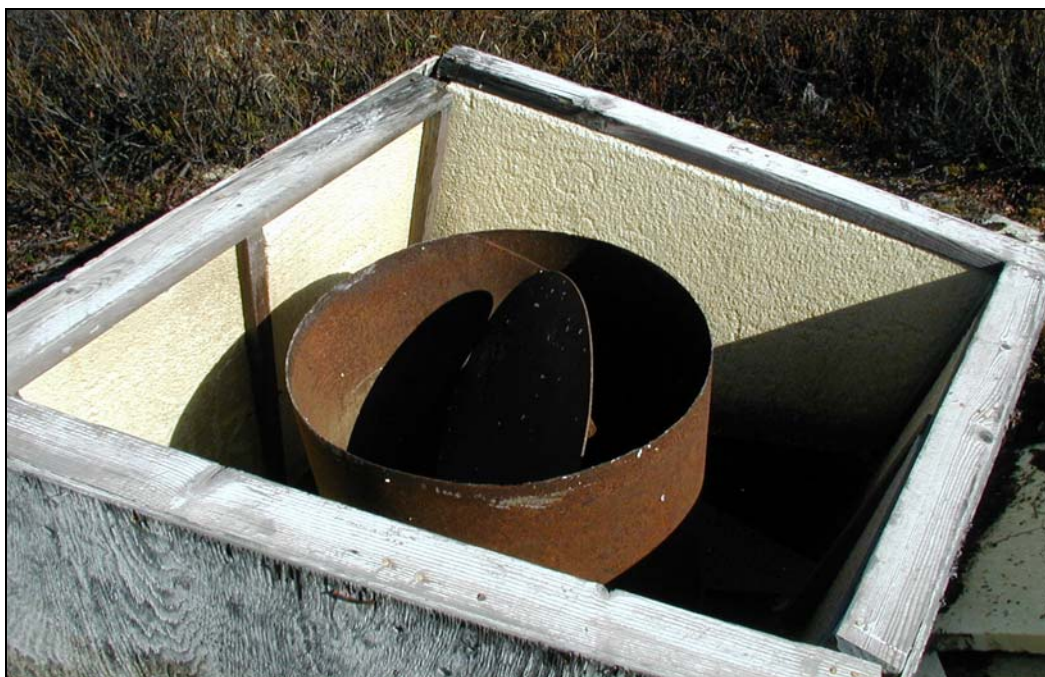
Now inaccessible at the end of the adit are three, approximately 1-m-diameter ventilation shafts that were augured down from the surface to the tunnel. These were designed to aid in natural convection cooling in the winter while the portal doors were opened. Apparently these were problematic to maintain, as surface water would migrate along the shaft, melt the permafrost, and form a conduit for surface water to travel to the tunnel, eventually icing in the vent and causing permafrost degradation problems (Fig. 10). Subsequent vents were installed after the failure of the previous. Currently the evidence on the surface consists of one ice-filled pipe extending above the surface with insulation debris around it, a vent pipe with a louver located in an uncovered insulated box, and a vent pipe located in an insulated box with a screened cover. Jim Buska of CRREL provided photos of the installation of the box for the vent pipe with the louver taken in June 1978. Sometime after the 1993 flooding event, the last of the three vents froze shut with surface water and has not been operable since. To aid in cooling the rear of the adit since that time, fans have been used to circulate the winter air after opening the portal doors, but with little efficacy.

Figure 10. Third vent installed from the surface to the rear of the adit, with a louvered pipe to close off the vent during the summer. The pipe is now ice-filled and inoperative.

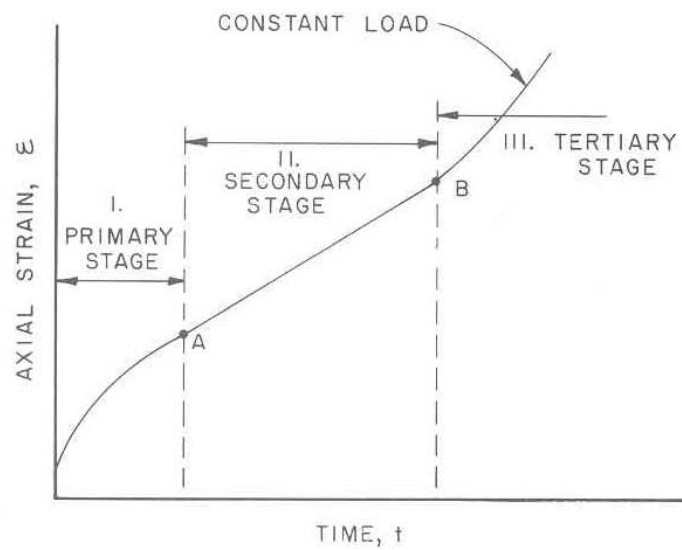
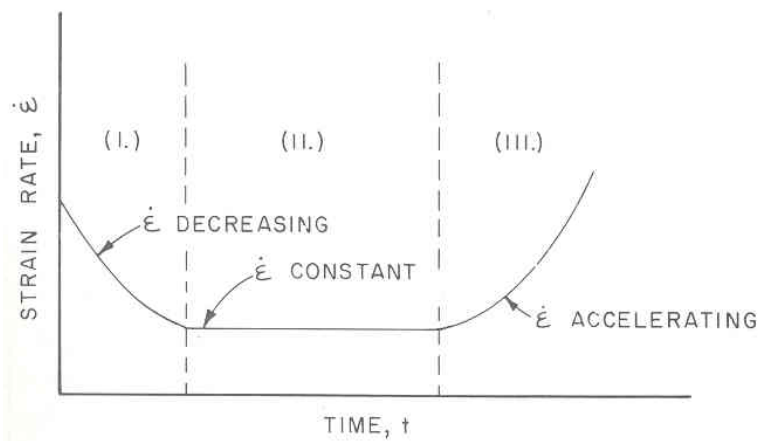
Plotting strain vs. time for a frozen soil sample that has undergone constant stress testing reveals the classic creep curve shown in Figure 12a. With loading, there will be an instantaneous deformation, the amount of which is determined by the magnitude of the load. If the load does not induce instant failure, then after this initial loading, the rate of deformation decreases until it reaches a theoretical constant value. This first stage is defined as primary creep. If the applied load exceeds the critical stress of the frozen soil, deformation will increase with time and will reach a second inflection point, resulting in secondary creep or steady state creep. If the applied load is high enough, or the variables affecting the strength of the soil are changed (i.e., temperature), the steady state creep will accelerate into failure, resulting in tertiary creep.

a. Stages of creep.

b. Strain rate vs. time.

Figure 12. Classic creep curves resulting from constant stress testing. (From Phukan 1985.)

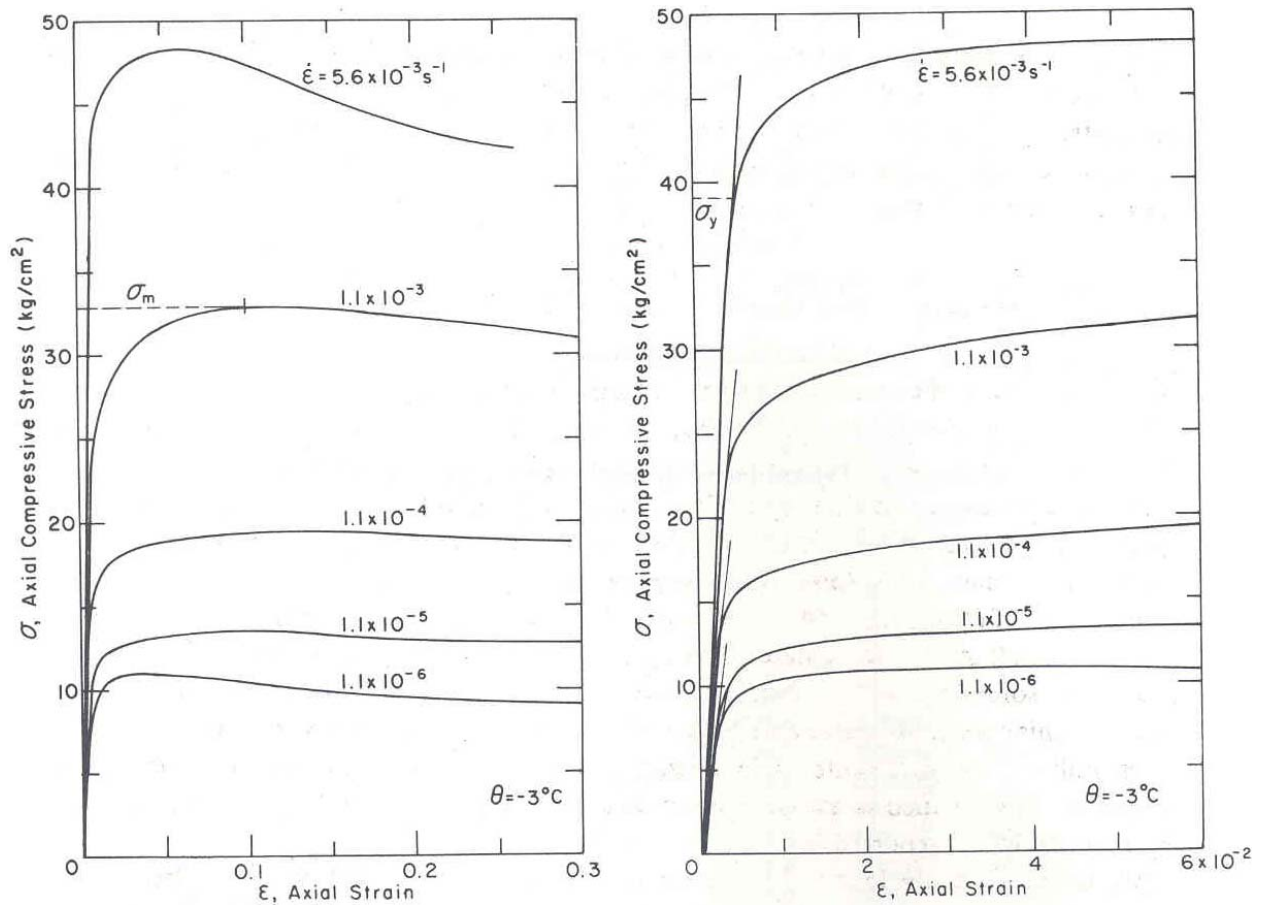
Zhu and Carbee (1987a) discussed the relationship between constant stress (creep) and constant strain rate (strength) tests. They reported that for the same soil, temperature, and strain rate, the applied stress in a creep test approximates the peak strength in a strength test. Figure 13 illustrates determination of peak strength and initial yield strength.

a. Constant strain rate test showing determination of peak strength σ_m .

b. Determination of initial yield strength σ_y .

Utilizing the initial yield strengths from the tested cores from the tunnel, determined as in Figure 13b, we see that at -2.0°C and a strain rate of $1 \times 10^{-3}/\text{s}$, the initial yield begins at approximately 1.4 MPa (Fig. 15). This is slightly lower than the value of 1.8 MPa that Zhu and Carbee (1987a) reported for initial yield strength at approximately the same strain rate and temperature. This is understandable, as the moistures for their remolded specimens were 40%, compared to our tested “undisturbed” tunnel cores of 50–190%. Higher moistures will yield lower strengths because of the increased ice volume, and the reconstituted samples would provide more uniform grain-to-grain contact than for a naturally deposited sample.

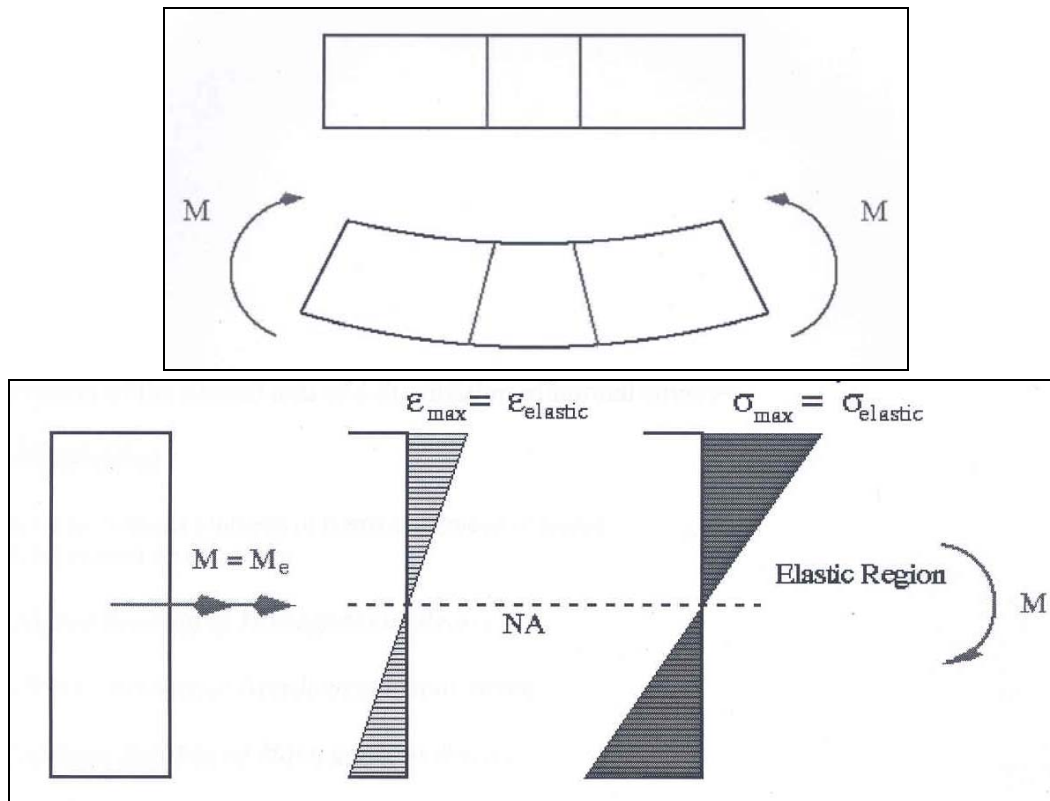
Consider the inter-bedded layering of the soil in the deforming portion of the adit as elastic, uniform in dimension, and isotropic. From field measurements we found most layers to be 0.2–0.3 m thick. Applying beam theory (Fig. 14) to model these layers, using a 0.2-m-high \times 0.3-m-wide \times

Figure 14. Simple rectangular beam in pure bending, showing the distribution of compression and tension stresses.

This is the maximum stress found on either the upper boundary (compression) or lower boundary (tension) immediately after the layer has delaminated from the bedding above. This analysis assumes that the load is uniformly distributed and is extremely sensitive to the thickness of the beam, where a 1/3 reduction in height results in an over two-fold increase in the stress (Table 3).

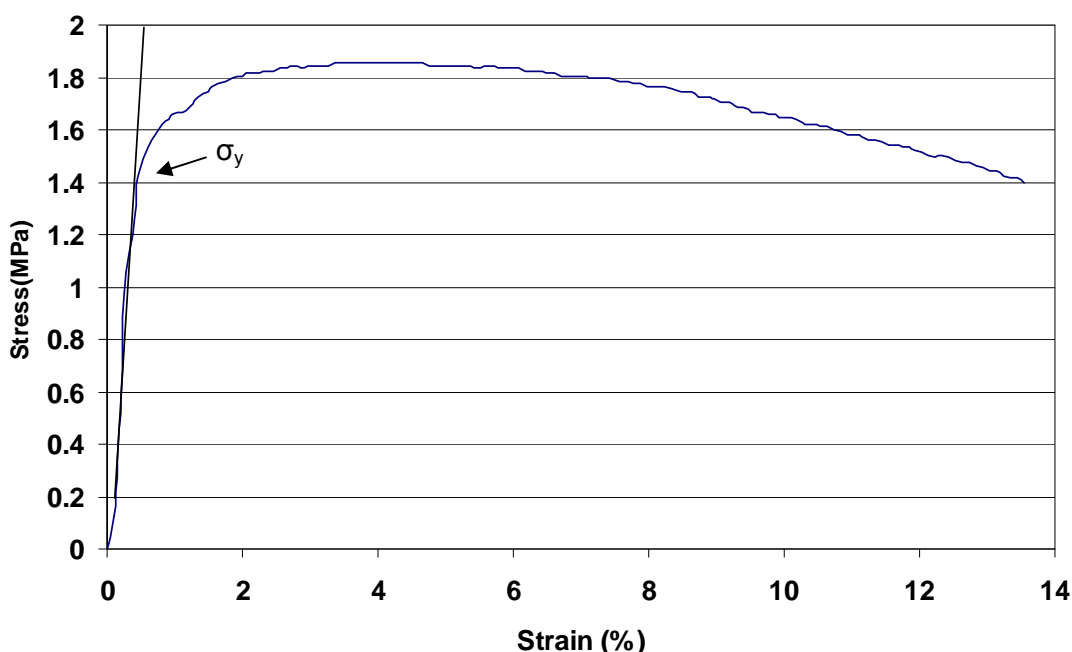
Figure 15. Core #1-H unconfined constant strain rate test at a strain rate of $1 \times 10^{-3}/\text{s}$ and -2.0°C . The moisture content was 84.7%.

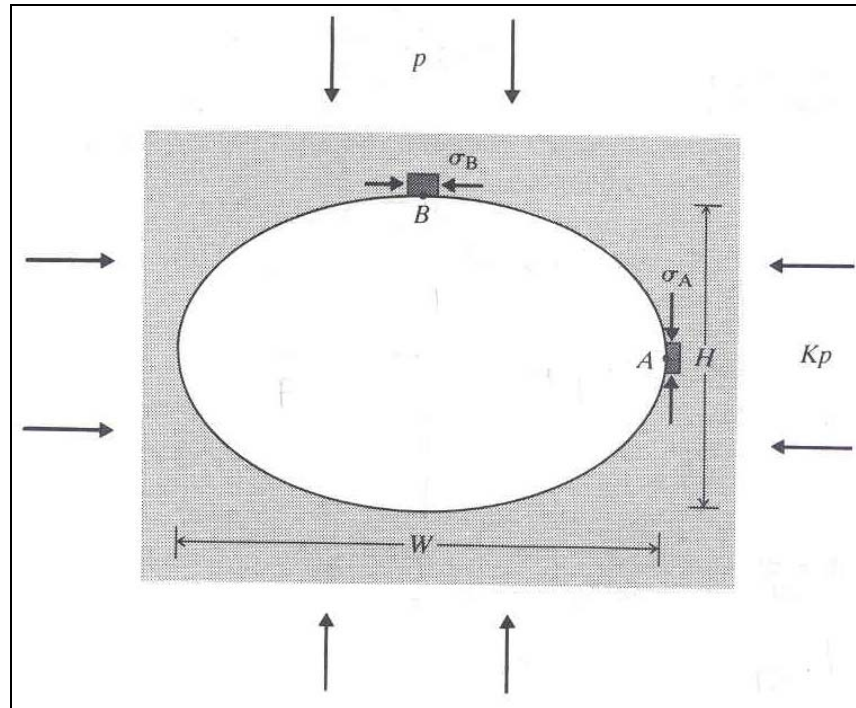
We now compare theoretical boundary stresses found around the perimeter of an elliptical opening in an elastic isotropic body. This is applicable to the front of the adit, where deformation has not occurred and the geometry is intact from the time of initial excavation. For the opening shown in Figure 16, we can compute the stresses found at the top (or bottom) of the opening and those found at the walls.

Figure 16. Vertical and horizontal boundary stresses determined by geometry and field stress. (From Brady and Brown 1993.)

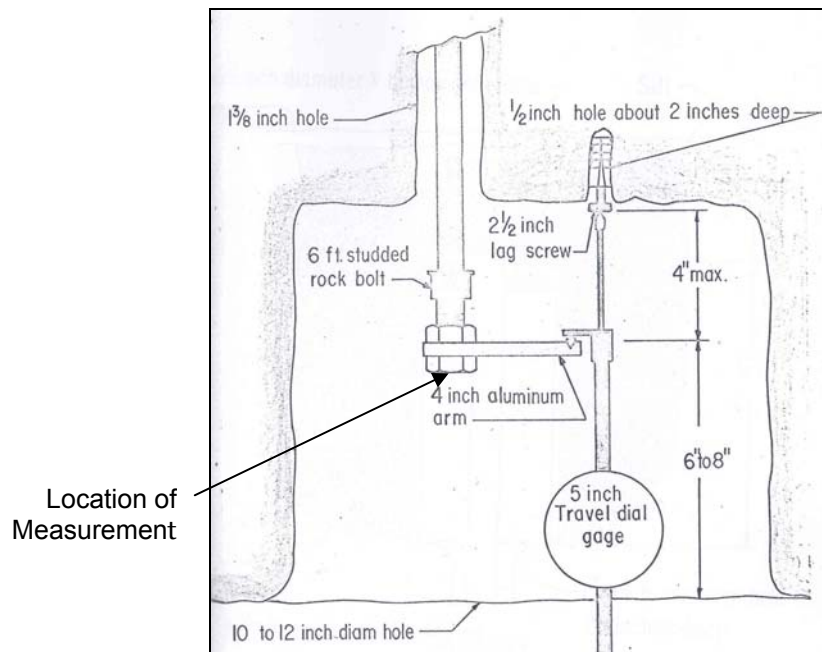
Figure E1. Rock bolt diagram, indicating the location of measurements.
